# A Case History on the use of High Strength Woven Geotextiles to Reinforce an Oil Sands Tailing Pond Closure

Andrew Mills, C.E.T.

Layfield Geosynthetics – Edmonton, Alberta, Canada
e-mail: geosynthetics@layfieldgroup.com

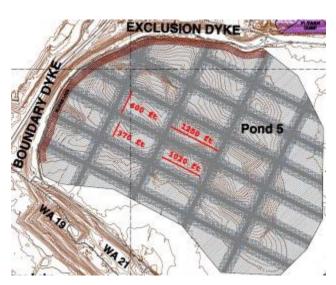
Figure 3. Proposed road layout on pond 5. (Suncor Tender drawing, used with permission).

The 2009/2010 road project involved 13 kilometers of road 90 m wide (Figure 3). The cross section of the road began with a 100 m wide layer of sewn high strength biaxial woven geotextile with a finished strength of 82.5 kN/m (Figure 2). On top of that was an 80 m wide layer of a biaxial geogrid (30 kN/m) overlapped 20 m in the center. Then drainage pipes were added in the direction of the road. Coke fill was then placed on top of these geosynthetics. The first lift was 1 m thick and 90 m wide. The second lift increased the center 60 m of road to a 2 m thickness. Then the center 30 m wide portion of the road was increased to a 3 m thickness. The initial 1 m thickness was to be placed with snowcats while the other lifts were to be placed with small dozers. The center road was for truck access with 40 ton articulated mine trucks. A more detailed review of the road design is contained
